ASSET MANAGEMENT PLAN

North Sydney Council

Stormwater Drainage Asset Class

Document ID: NSC AMP Stormwater Drainage Asset Class 2025

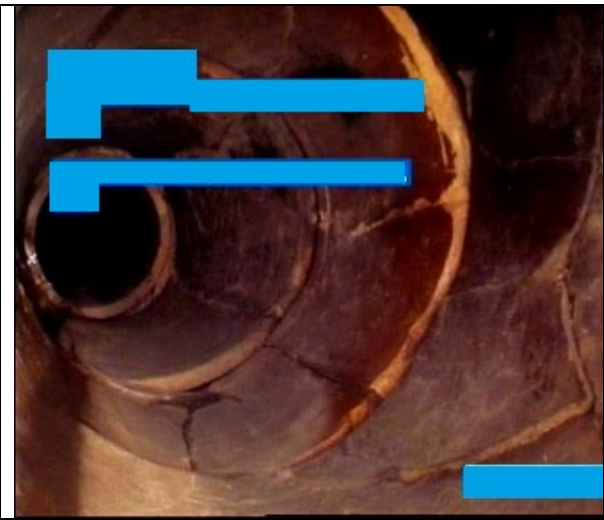
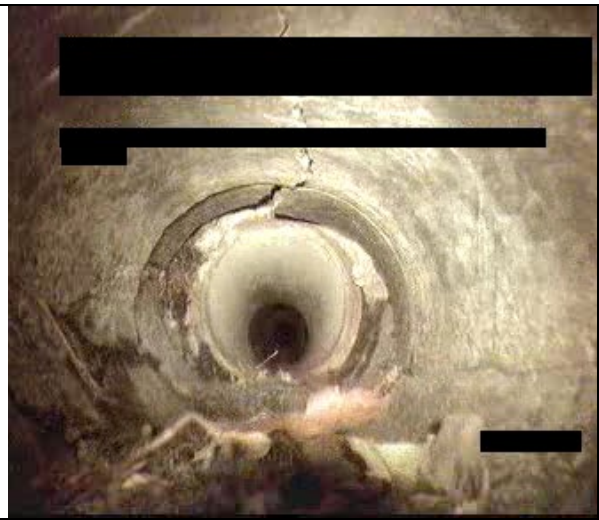
Stormwater Pipes in very poor condition – collapsed and blocked

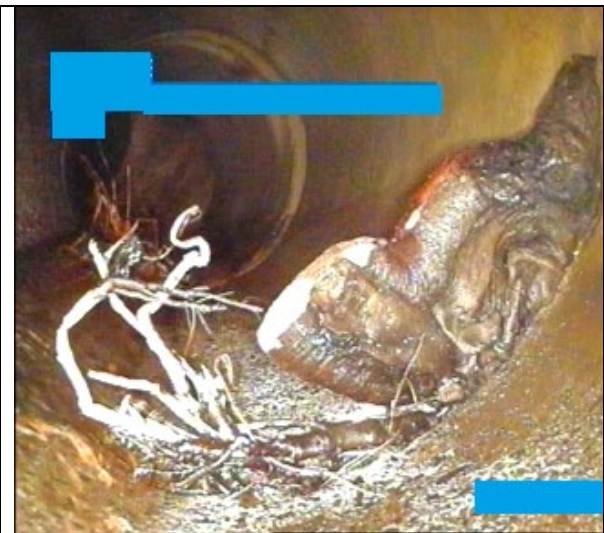
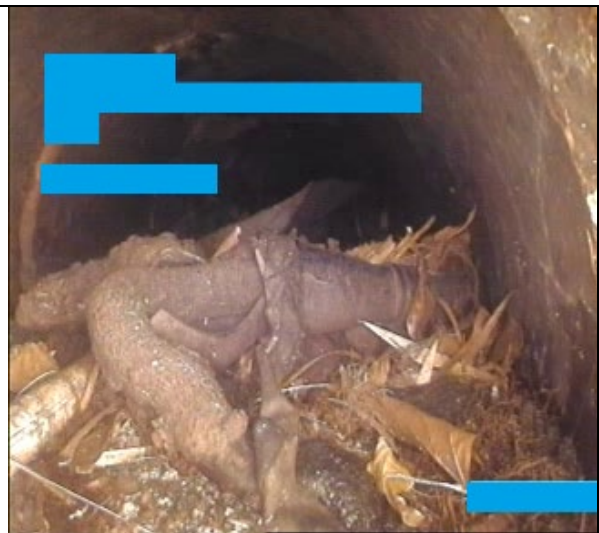
Stormwater Pipes in very poor condition – Tree root infiltrations and blocked

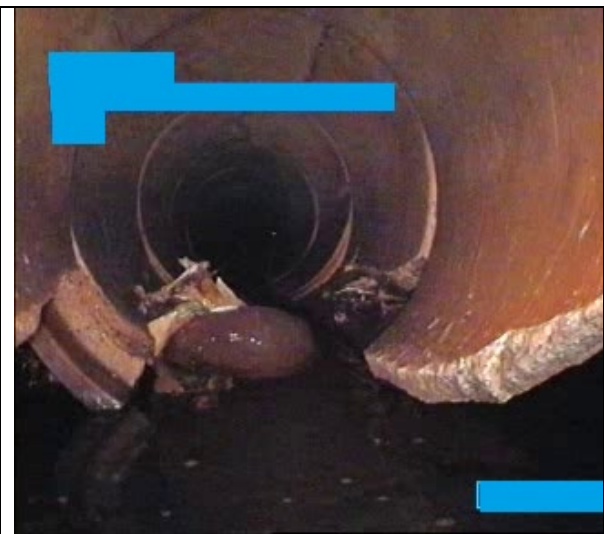
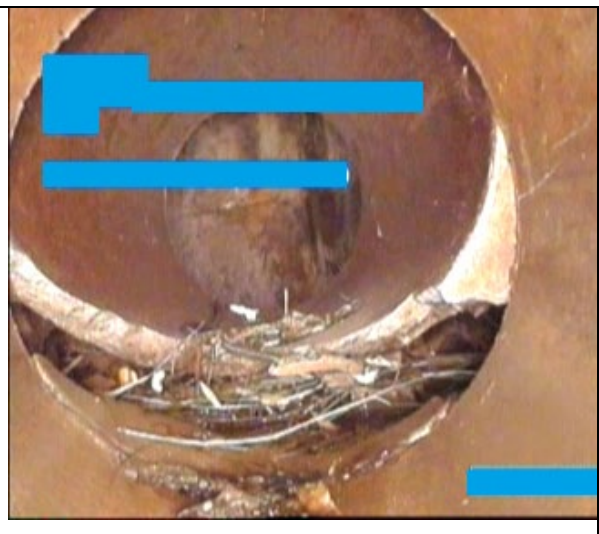
Stormwater Pipes in very poor condition – collapsed

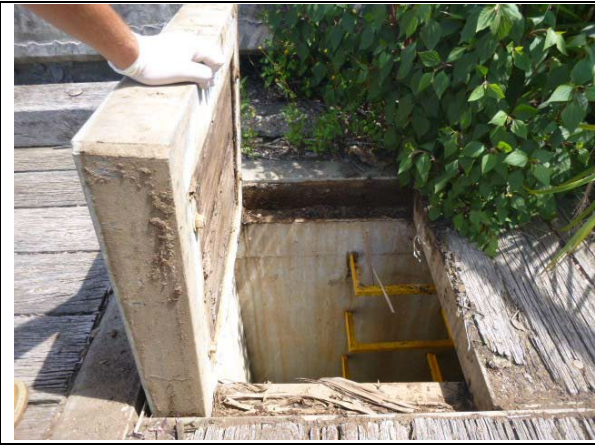
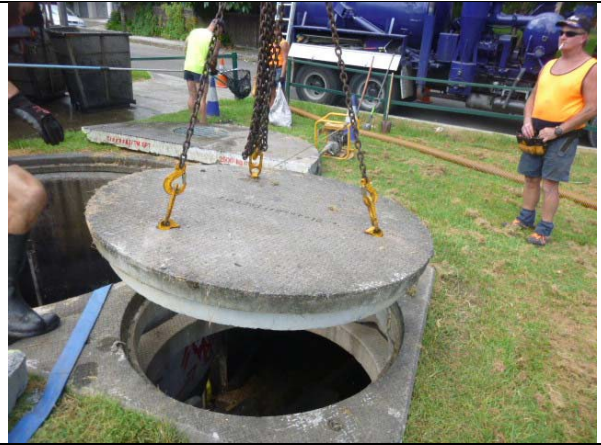
Lids are too heavy - The wood is starting to chip; they should be replaced. Lifting points rusted or broken off

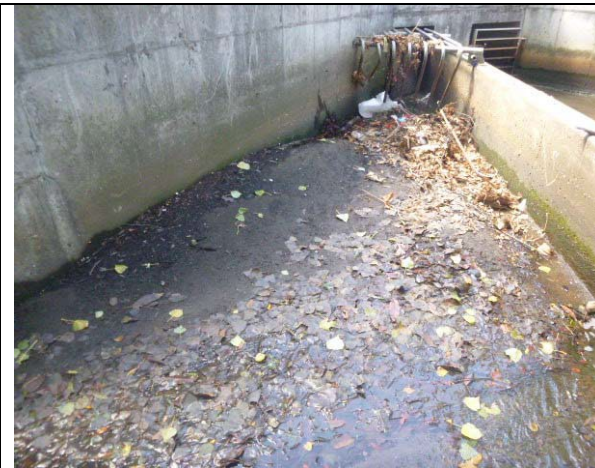
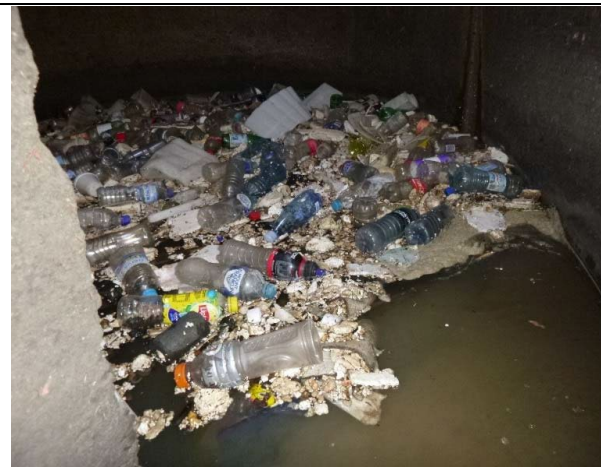
Sediment and trash build up in front of the weir and in pits generally – low capacity.

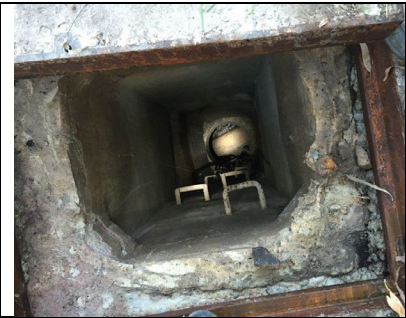
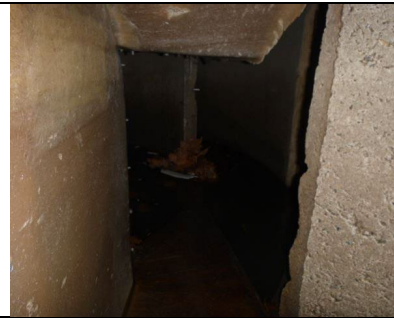
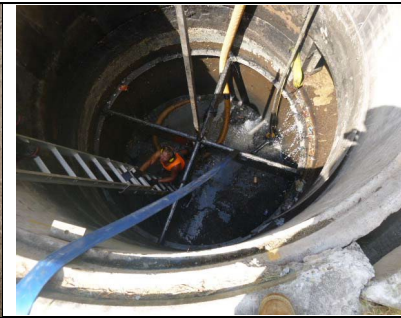
Difficult access to a lot of GPTs for maintenance

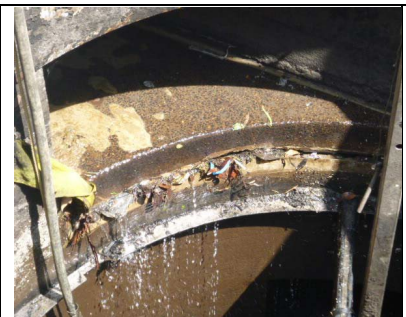
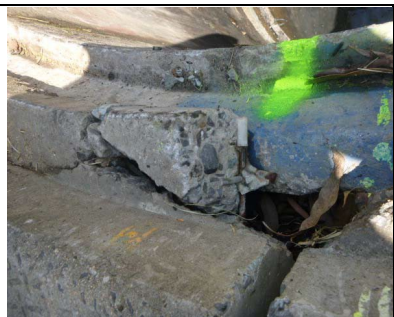
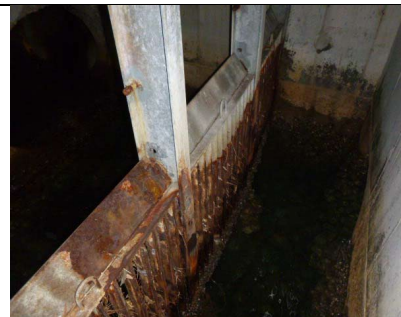
Corrosion and structural damage to GPT manhole covers

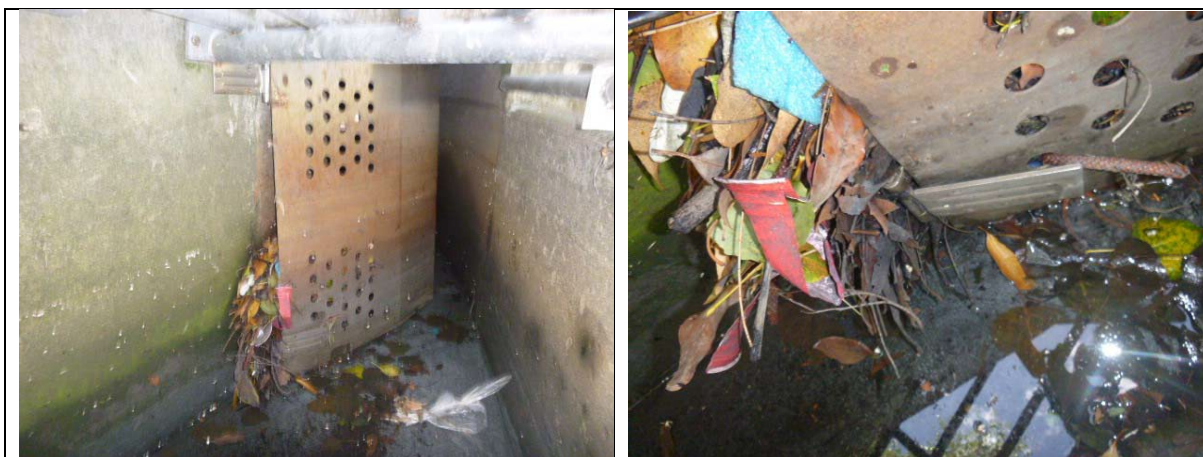
The floatables flap was jammed open due to a broken hinge and pollution trapped in it stopping it closing.
